# Manhole Inspection Summary

Manhole # S47E\_\_016MH

Insp Date: **7/31/08 10:46 AM**

**Location** Address: **Lombard**

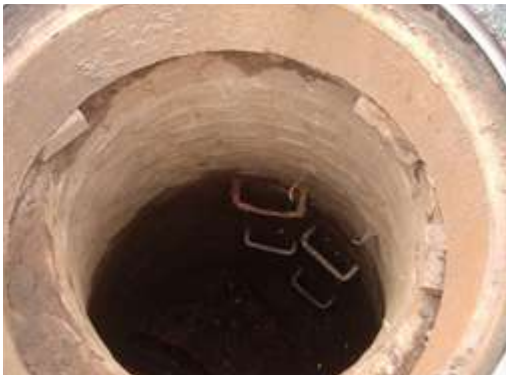
Defect 1

Condition: ☐ Sound ☐ Cracked ☐ Root Intrusion ☒ **Loose Brick** ☐ Deteriorated

loose brick

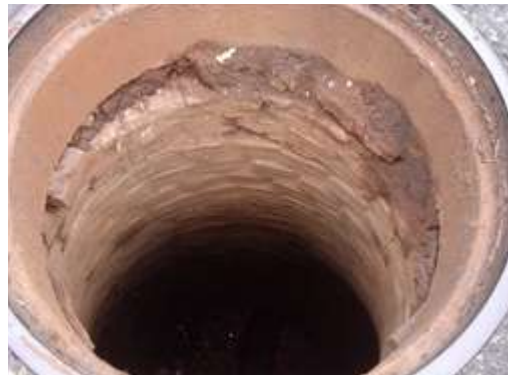
Defect 2

Infiltration: ☐ None ☐ Joint ☐ Cracks ☒ **Mortar** ☐ Roots ☐ Wall

Infiltration: ☐ None ☐ Joint ☐ Cracks ☐ Mortar ☐ Roots ☒ **Wall**

infiltration

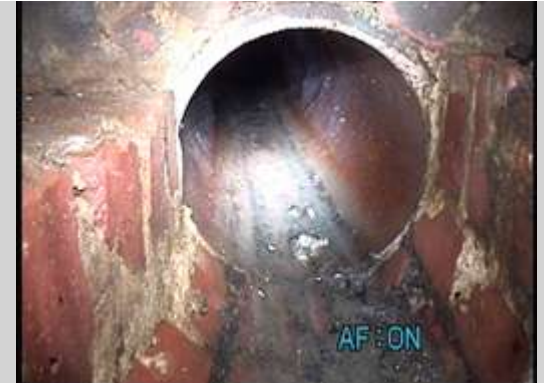
12 O'Clock Outflow

8 in. Circular Gravity Sewer  
Pipe Out @ 12 O'Clock

Pipe Height: **8.4** (in.) Rod and Bar (Angled)  
Pipe Material: **Clay** ☐ Pipe Lined  
Invert Depth: **10.05** (ft.) Flow Characteristics: **None**  
Deposits: ☒ None ☐ Mud ☐ Sludge ☐ Debris ☐ Grease  
Silt Depth: (in.) Deposits Extent:  
Infiltration: **None** Pipe Seal Cond: **Sound**

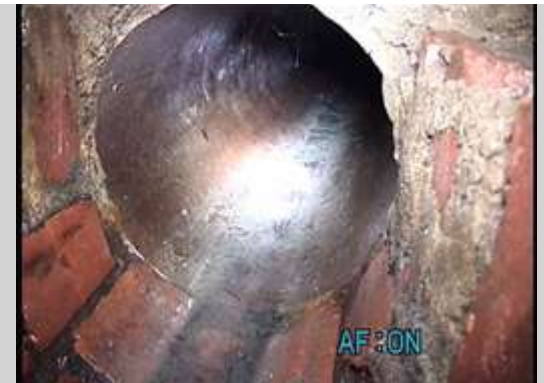
9 O'Clock Inflow

8 in. Circular Gravity Sewer  
Pipe In @ 9 O'Clock

Pipe Height: **8.4** (in.) Rod and Bar (Angled)  
Pipe Material: **Clay** ☐ Pipe Lined  
Invert Depth: **10.00** (ft.) Flow Characteristics: **None**  
Deposits: ☒ None ☐ Mud ☐ Sludge ☐ Debris ☐ Grease  
Silt Depth: (in.) Deposits Extent:  
Infiltration: **None** Pipe Seal Cond: **Sound**
